**Sandyford Business District
Cycle Infrastructure Review**

Localised Issues

P18-055-DG-004

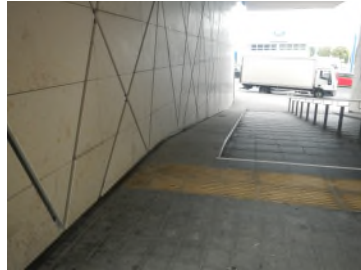
Priority 3: Issue

Cyclists can access Beacon shopping centre at a number of locations with bicycle parking stands provided. The entrance from Blackthorn Drive provides ramps which may be used by cyclists. It is unclear if the gradient is too steep for cyclists who may become fatigued on the incline.

The gradient of the ramps should be further assessed and landings provided if necessary.

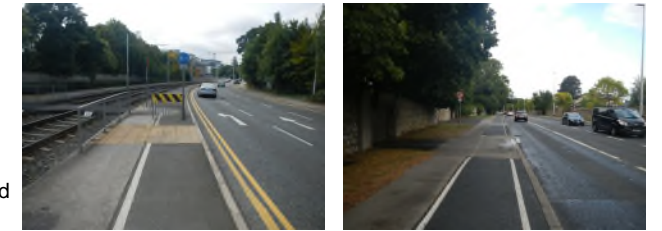
Priority 1: Issue

Luas crossing for cyclists and pedestrians creates conflict point. Additionally, high volumes of cyclists identified using running carriageway.

Revise cycle facilities to remove conflict point between pedestrians and cyclists.

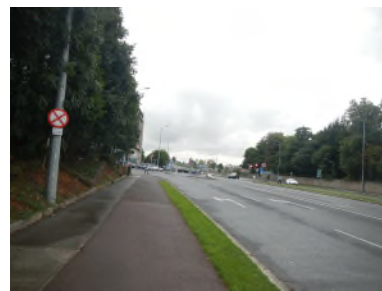
Priority 1: Issue

Dropped kerbing at entrances on the northern verge of Leopardstown Road resulting in an uneven surface and poor ride quality for cyclists.

Provide continuous cycle track on the northern verge of Leopardstown Road giving priority to pedestrians and cyclists at residential accesses with a maximum kerb height of 25mm.
