**Sandyford Business District
Cycle Infrastructure Review**

Issues at Junctions

P18-055-DG-003

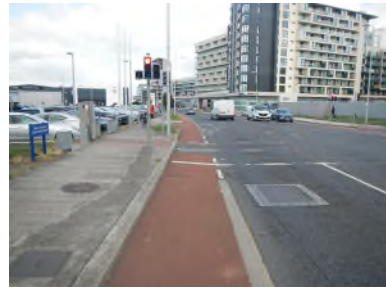
Priority 1: Issue
No cycle facilities have been provided for right turning cyclists at the Blackthorn Drive/Blackthorn Road and Blackthorn Drive/Carmanhall Road signalised junctions with cyclists identified waiting on pedestrian footpath at pedestrian crossing.

Recommendation
Revise junctions to provide facilities for right turning cyclist at both junctions. Additionally, a shared use surface should be considered to allow cyclists to continue on the southern verge of Blackthorn Drive to access the Beacon shopping centre.

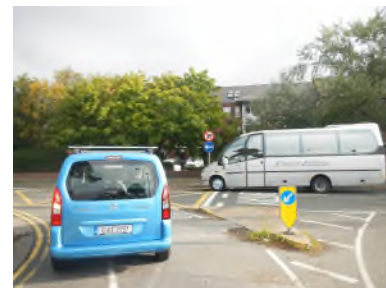
Priority 1: Issue
No facilities provided for cyclists attempting to access the ESB arm of the roundabout. Cyclists may attempt to use the pedestrian crossing on the eastern arm and continue on the existing footpath.

Recommendation
This will be addressed as part of the ESB Link Road scheme.

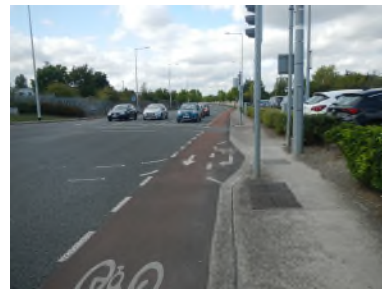
Blackthorn Drive/Benildus Avenue Signalised Junction

Priority 2: Issue 1
No signal for right turning cyclist.
Recommendation
Provide signal phase and a detector loop for right turning cyclists.

Priority 2: Issue 2
Cyclists travelling west on Blackthorn Drive must move into running carriageway as a result of island located within cycle path.
Recommendation
Set back the island providing continuous cycle facilities through the junction.

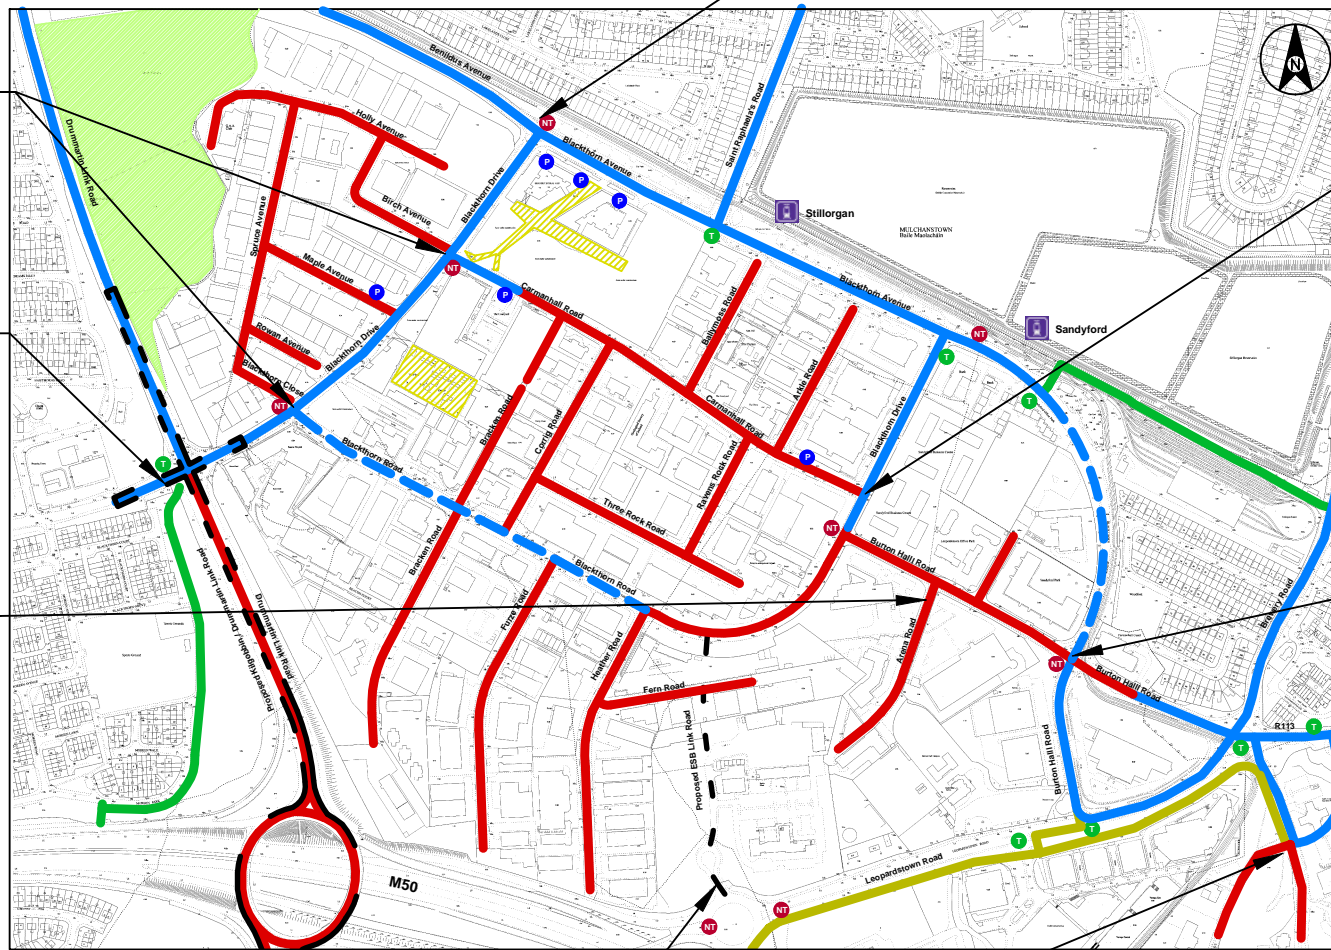
Priority 2: Issue
Insufficient facilities have been provided for cyclists traveling between the northern and southern arms of the junction. There is limited visibility to vehicles approaching from the south for cyclists wishing to continue east from Maple House arm of the junction.

Recommendation
The junction layout should be revised to provide continuous cycle facilities through the junction for cyclists. Additionally, toucan crossings should be provided on the northern and eastern arms of the junction.

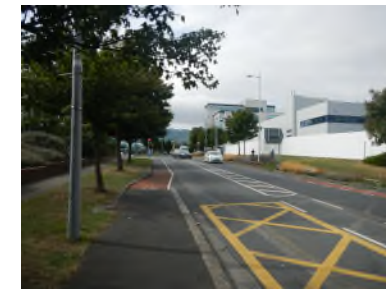
Priority 2: Issue
A cycle track is provided for southbound cyclists on Blackthorn Road and does not provide a ramp to access the lower level of the running carriageway resulting in cyclists unable to turn right onto Carmanhall road.

Recommendation
Provide ramps and a cycle lane on the eastern verge of Blackthorn Road at its junction with Carmanhall Road.
