**Sandyford Business District
Cycle Infrastructure Review**

**Enforcement and
Maintenance Issues**

P18-055-DG-005

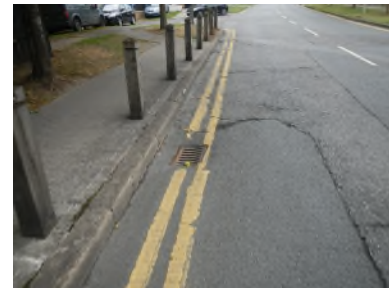
Gullies not flush with the pavement

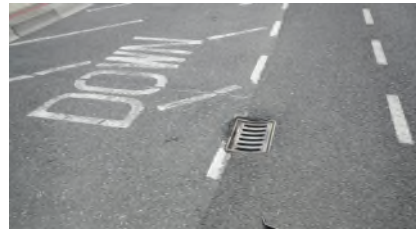
Gullies not flush with the pavement

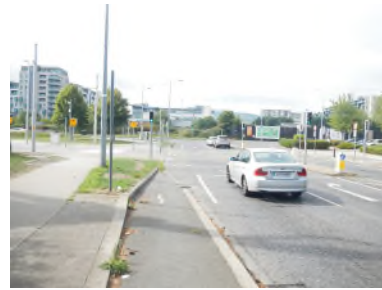
Manholes in cycle lane

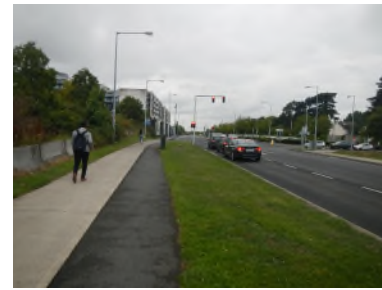
Grass encroaching cycle facilities

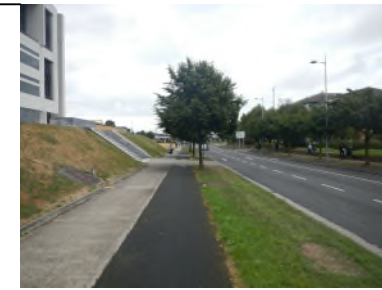
Grass encroaching cycle facilities

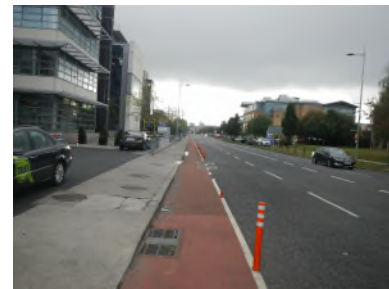
Manholes in cycle lane

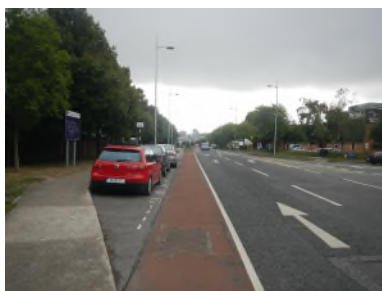
Poor pavement condition

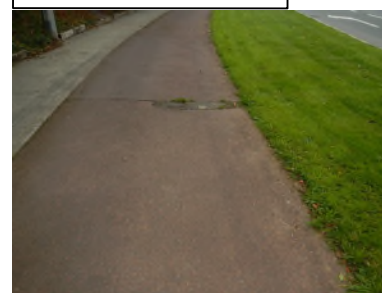
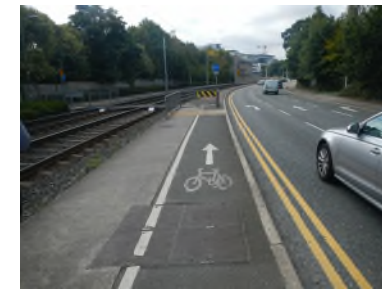
Manholes in cycle lane/track

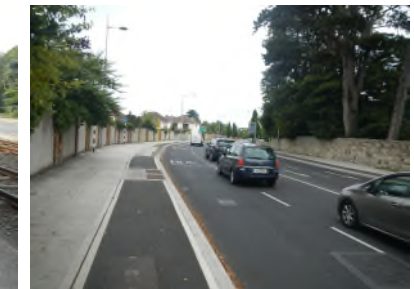
Shrub is encroaching on footpath resulting in pedestrians walking into cycle lane which may result in a cyclists/pedestrian collision. Cut back vegetation.
