**Sandyford Business District
Cycle Infrastructure Review**

Discontinuous Cycle Facilities

P18-055-DG-002

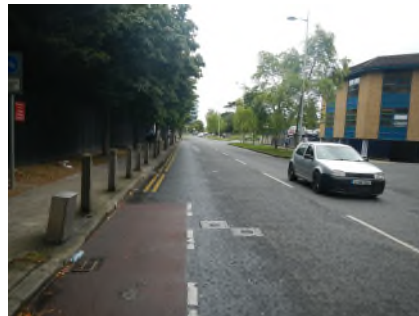
Priority 3 Issue

Insufficient cycle facilities provided on Carmanhall Road which is considered a main spine road within business district.

Provide cycle facilities on both side of Carmanhall Road to tie into existing cycle facilities.

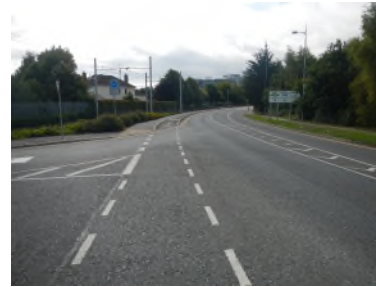
Priority 2 Issue

No cycle facilities provided for northbound cyclists from Burton Hall Road to Blackthorn Avenue which may lead to cyclists continuing on footpath.

Provide a contraflow cycle track on the western verge of Blackthorn Avenue.

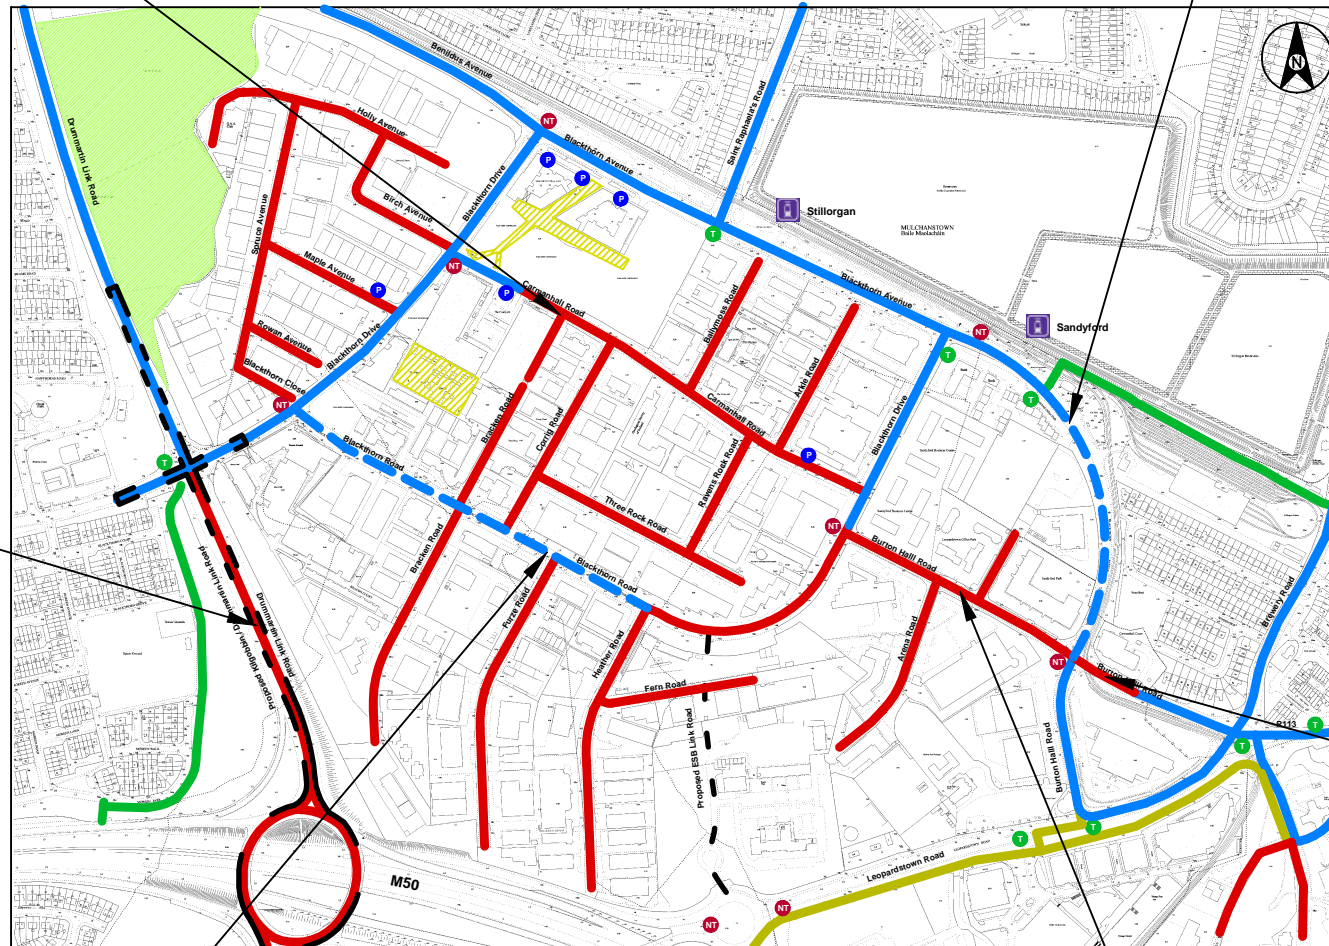
Priority 1 Issue

No cycle facilities provided on Drummartin link road from its junction with Blackthorn Drive continuing south over the M50.

Recommendation

Provide cycle facilities on Drummartin Link Road from existing facilities on Kilgobbin Road to the south and north of the Blackthorn Drive signalised junction.

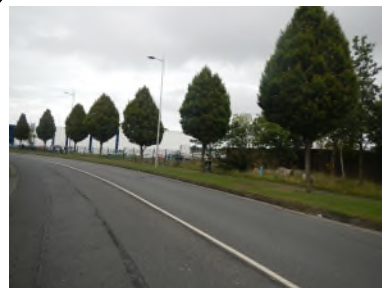
Priority 2 Issue

No cycle facilities provided on Blackthorn Road which is considered a main spine road within business district. Several cyclists identified cycling on grass verge on southern side of road where there is a risk of slips and falls.

Provide cycle facilities on both side of Blackthorn Road to tie into existing cycle facilities.

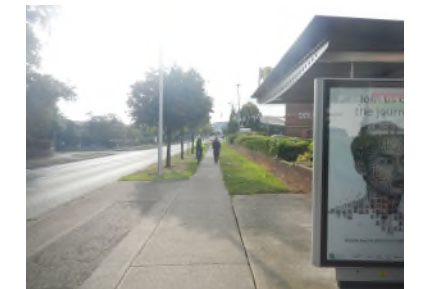
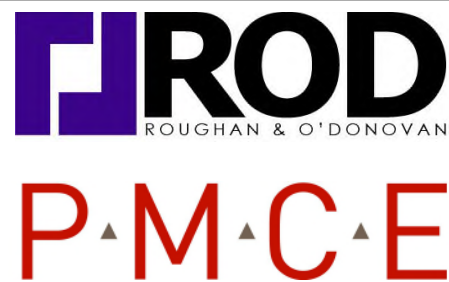
Priority 1 Issue

No cycle facilities provided on Burton Hall Road between it junctions with Blackthorn Avenue and Blackthorn Road. Several cyclists identified cycling on grass verge on southern side of road.

Provide cycle facilities on both side of Burton Hall Road to tie into existing cycle facilities.
